Pre-Purchase Inspection Report

Property: 4128 Rue Cartier, Montreal QC

Type: Duplex, 1948, brick veneer

Inspection date: July 6, 2026

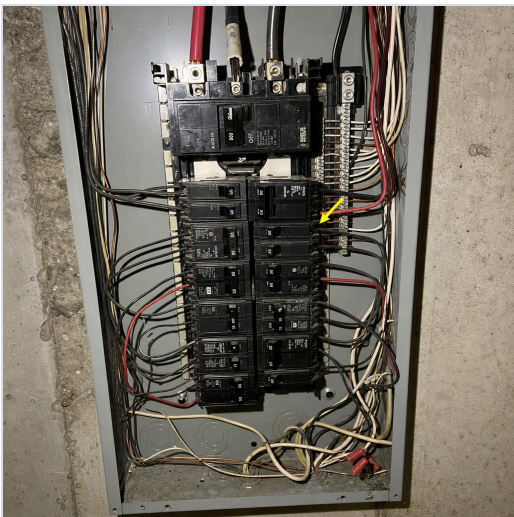
MAJOR Electrical: double-tapped breaker. Two conductors terminate on a single 15 A breaker at position 07 of the main panel. This is a defect under current standards and a potential overheating point. Recommend correction by a licensed electrician.

Photo 1. Main panel, position 07, double tap visible.

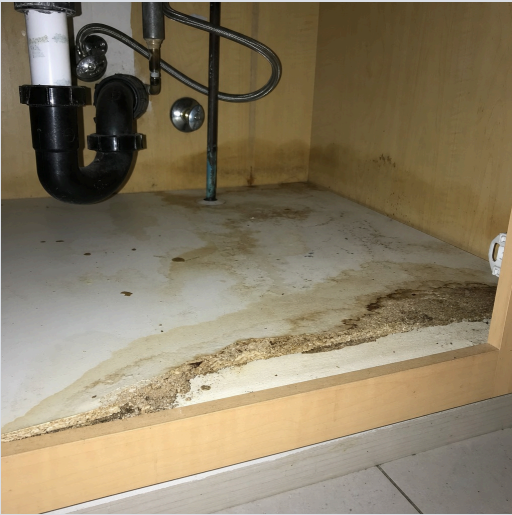
MINOR Plumbing: moisture damage under kitchen sink. Swollen particleboard and staining at the cabinet floor. Surfaces were dry at inspection. Likely historical; monitor and reseal supply connections.

Photo 2. Kitchen sink cabinet, staining and swelling.

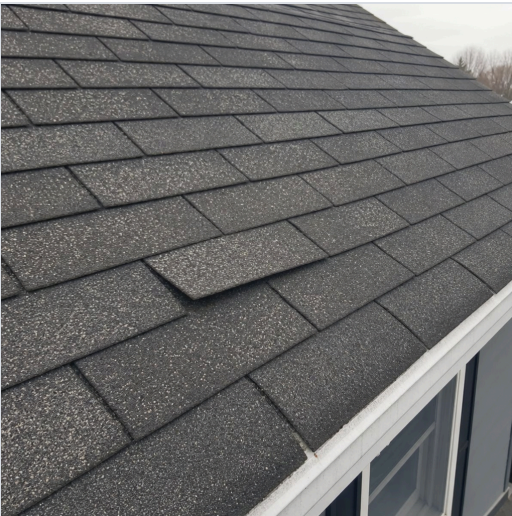
MINOR Roof: granule loss and lifted shingle. South slope shows uniform granule loss consistent with age (approx. 18 years) and one lifted tab. Serviceable short term; budget replacement in 3 to 5 years.

Photo 3. South slope, granule loss, lifted tab center-frame.

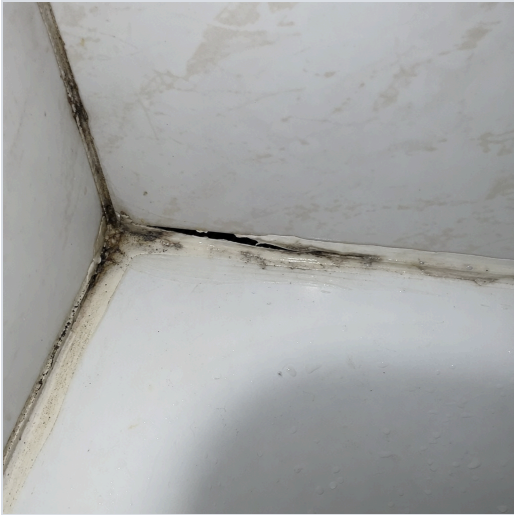
MINOR Bathroom: failed caulking at tub surround. Mildew and a gap at the tile joint allow water behind the surround. Re-caulk; verify no soft spots in adjacent drywall.

Photo 4. Tub surround, gap at tile joint.

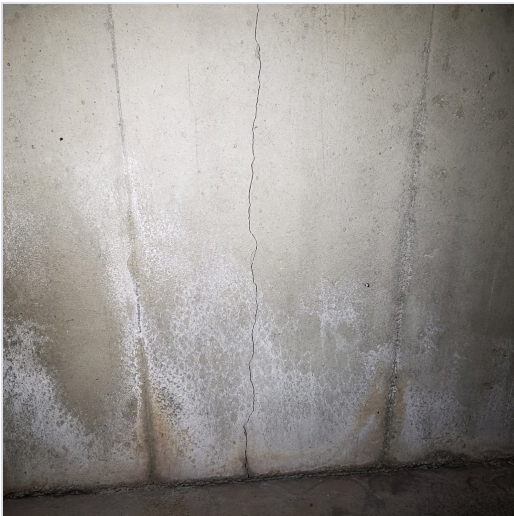
INFO Foundation: hairline shrinkage crack. Vertical hairline crack with minor efflorescence, west wall. Typical of poured concrete of this age; no displacement. Monitor annually.

Photo 5. West foundation wall, hairline crack.
